ABB specific vendor error codes
extensions for OCPP 1.6 Status
Notification message

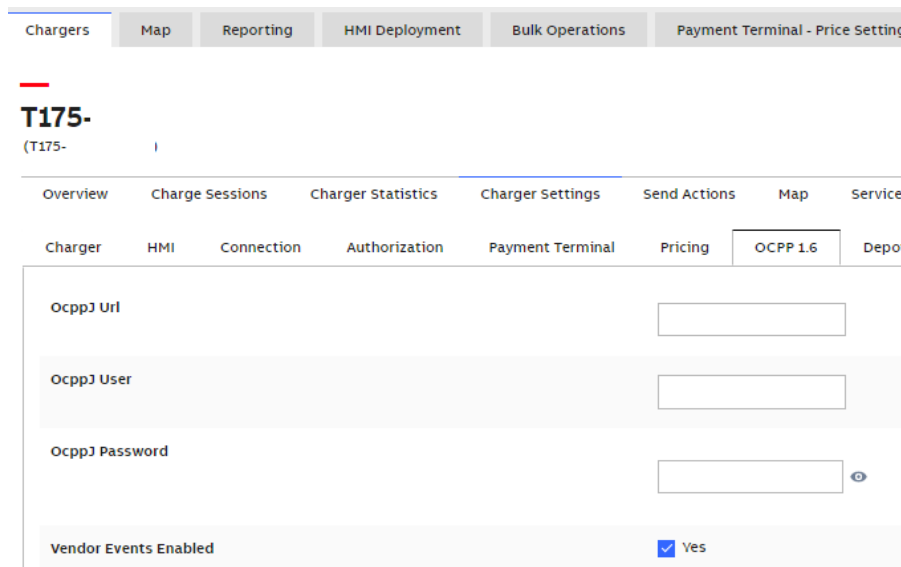
Sending the vendorErrorCodes can be enabled in the ABB Web tools by setting “Vendor Events Enabled”. By default, it is switched off for backwards compatibility.
